Manhole Inspection Summary

Manhole # S43K__005MH

Insp Date: **6/4/08 10:49 AM**

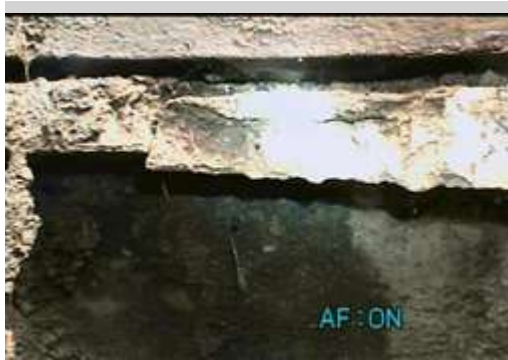
Defect 1

Condition: ☐ Sound ☒ **Cracked** ☐ Root Intrusion ☐ Loose Brick ☐ Deteriorated

CHIMNEY_COND_CRACKED

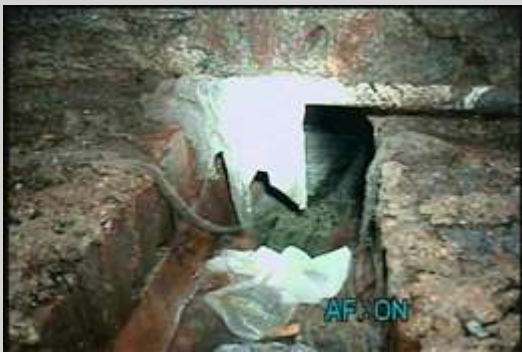
12 O'Clock Outflow

8 in. Circular Gravity Sewer
Pipe Out @ 12 O'Clock

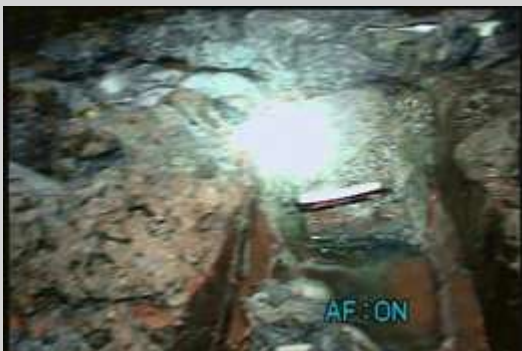
5 O'Clock Inflow

channel blocked by debris

Deposits: ☐ None ☐ Mud ☐ Sludge ☒ **Debris** ☐ Grease

Silt Depth: 8 (in.) Deposits Extent: **Heavy**
